## ROTTERDAM ZOO POND SOLIDS CONTROL

Rapid pond cleaning in anticipation of the zoo's 150th anniversary celebration and Royal visit.

**PRODUCT APPLIED:** MicroAktiv®-AL3 Pond & Lake Cleaner

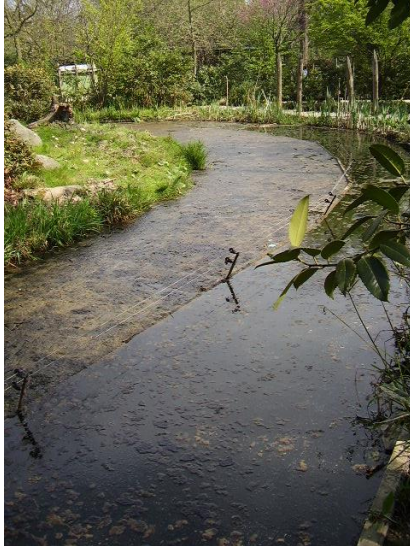
Before Treatment

Groundwater used as water supply for the pond containing significant iron concentrations which aids the algae growth.

The solids were examined to ascertain their nature. Test kits were used to determine the water chemistry. MicroAktiv®-AL3 Pond and Lake Cleaner was applied as follows:

Day 1: 2.2 kg

Day 2: 2.2 kg

Day 15: 1.1 kg

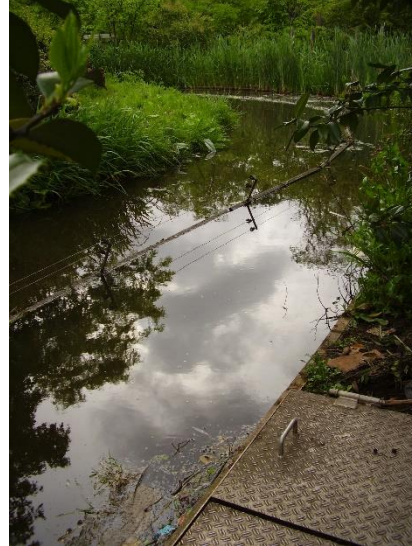
15 Days After Treatment

By day 15 of the **MicroAktiv®-AL3** application program, the solids in the pond had disappeared from the surface of the pond and the water was clear. See the photos above.

**MicroAktiv®-AL3** Pond and Lake Cleaner rapidly clarified the pond of surface and suspended solids in preparation for the anniversary celebration at the zoo. The product was easy to apply and economical, compared to the alternative treatments.
